Report No. E 296

Instruction manual for installation and operation of  
Constant Speed propeller model

HO-V92

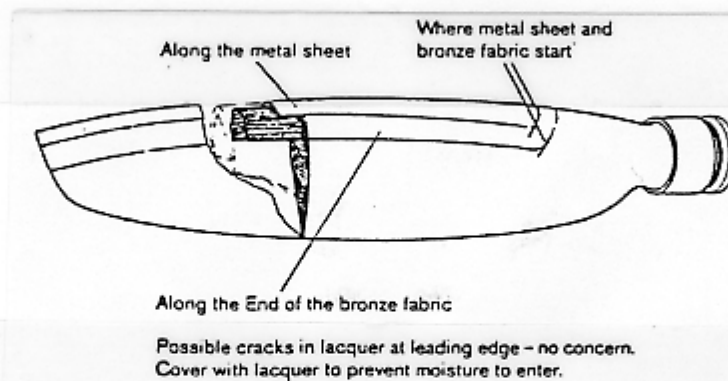
- A fine crack along the blade tipping or along the end of the bronze fabric is not dangerous. A fine crack at the beginning of the bronze fabric or blade tipping is also not dangerous. Sometimes such cracks occur, they are a normal indication of the different expansion of the different materials (wood, brass, bronze fabric).

During the maintenance period a lacquer should be used to cover such cracks and protect the blades against penetration of moisture.

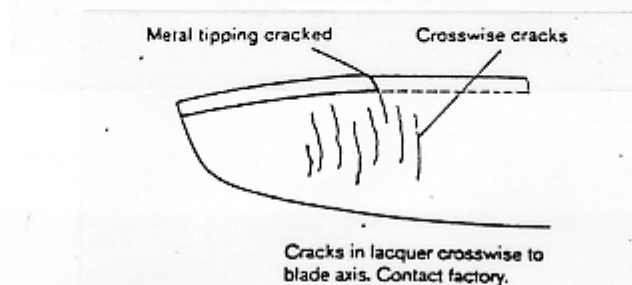
- Fine cracks in the lacquer surface or in the metal tipping across the blade axis are indications of bending vibrations. The factory should be consulted regarding airworthiness. Send a photograph for easier determination.
